Ambush Rock Restoration – Updates from 2024

Kootenai Tribe of Idaho
Environmental Department

EPA Grant - Columbia River Basin Restoration Funding Assistance Program

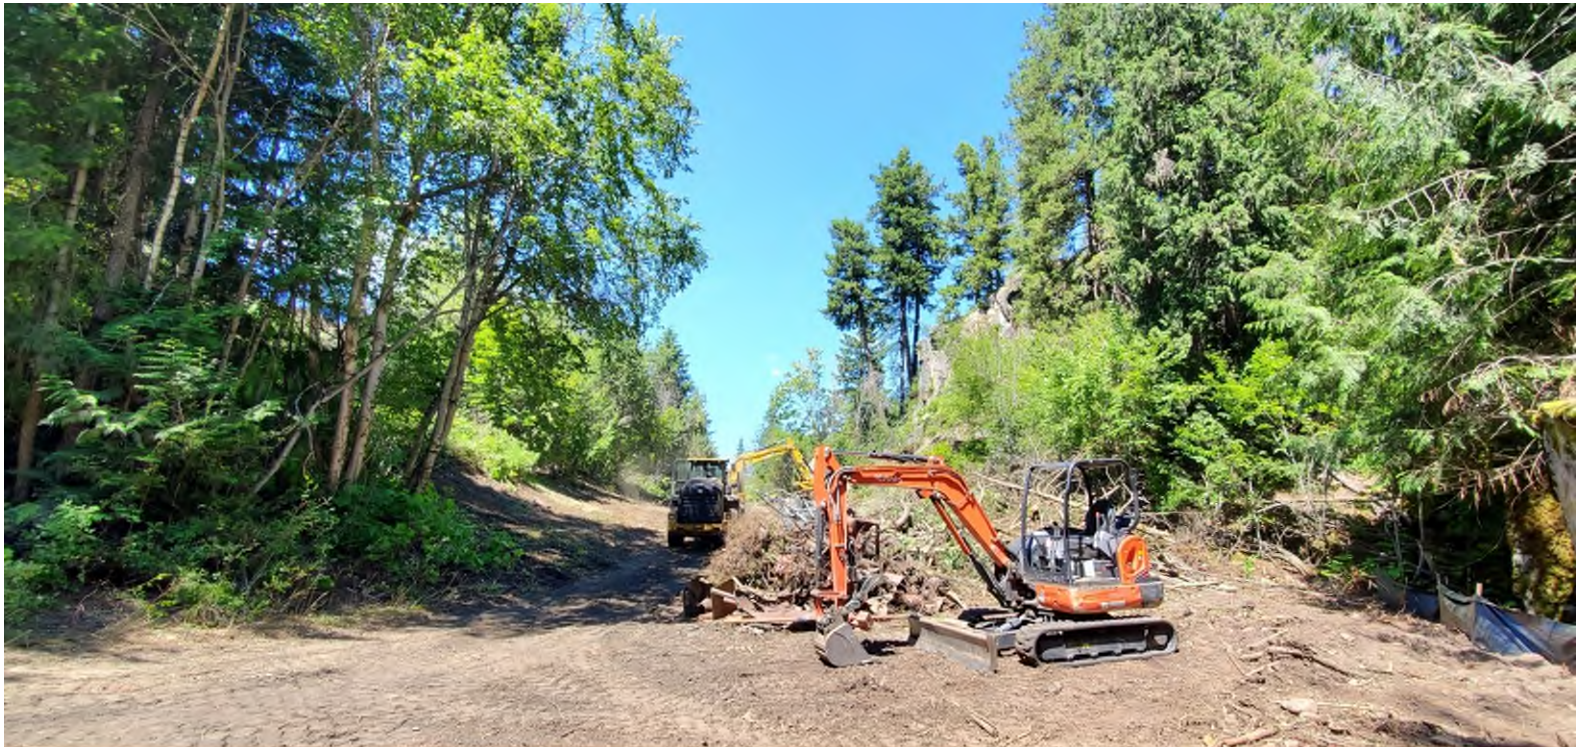
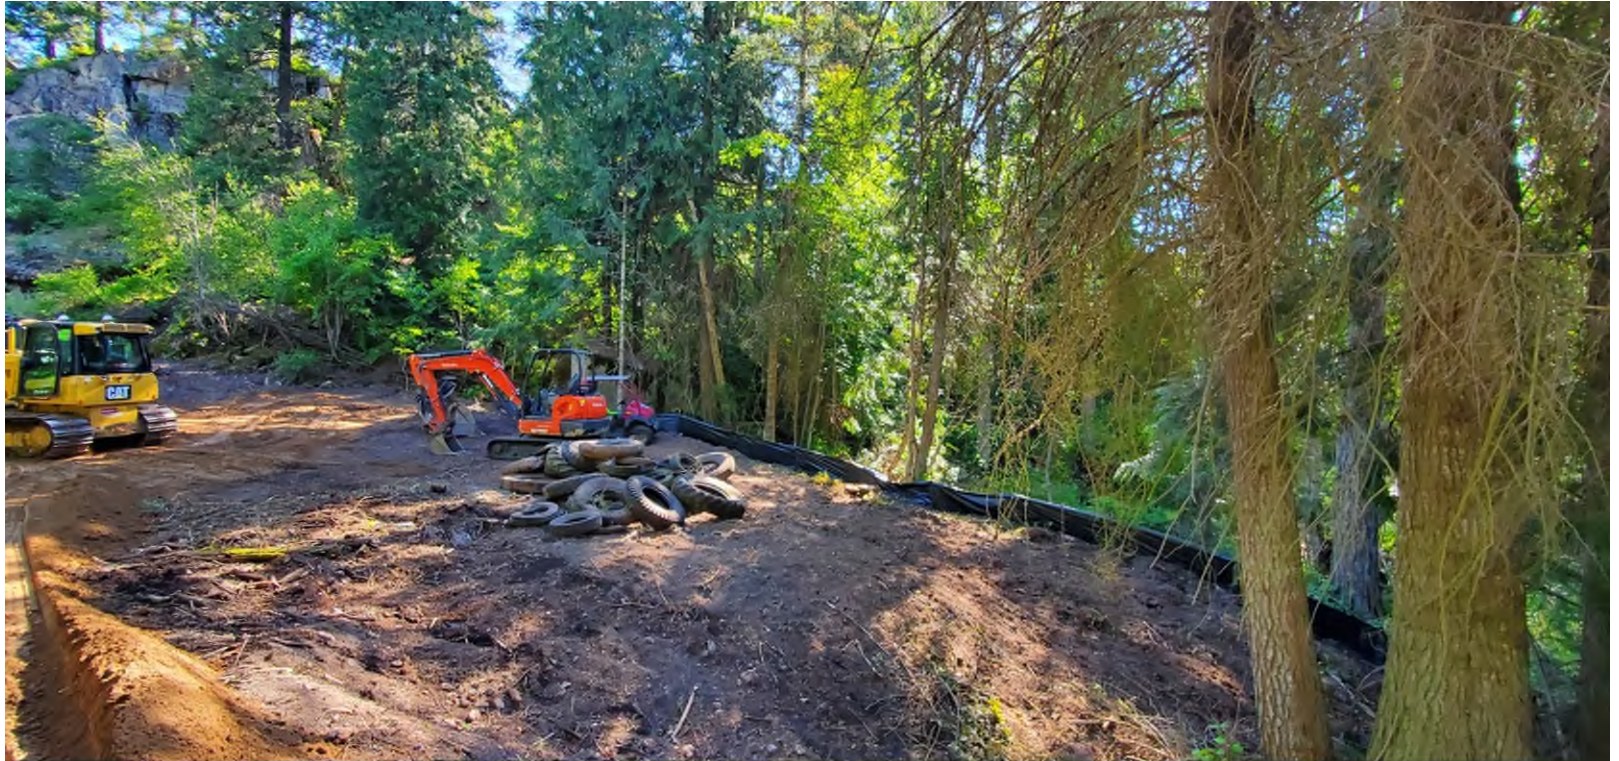
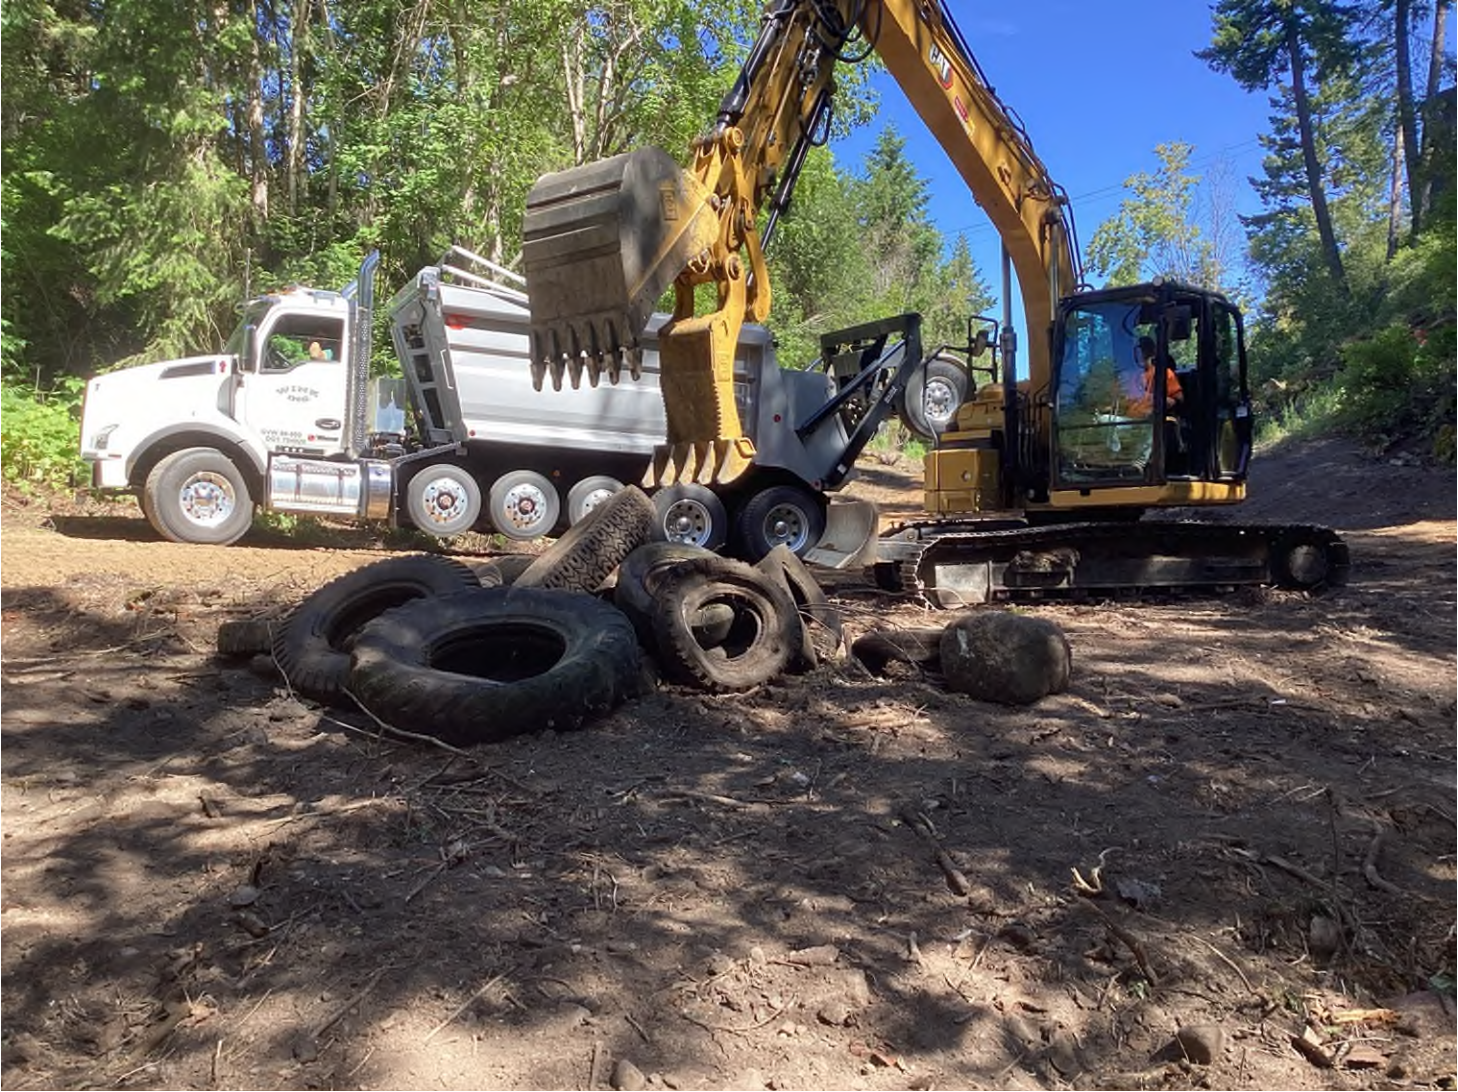
Debris Removal

- 31.4 tons of debris removed and recycled
- Metal taken to the scrap yard
- 14,367 cubic yards of cap and cover material
- Clean-up ran from 6/17 through 7/24
- **Fun Fact: Due to the era of the dump, plastic was not present**

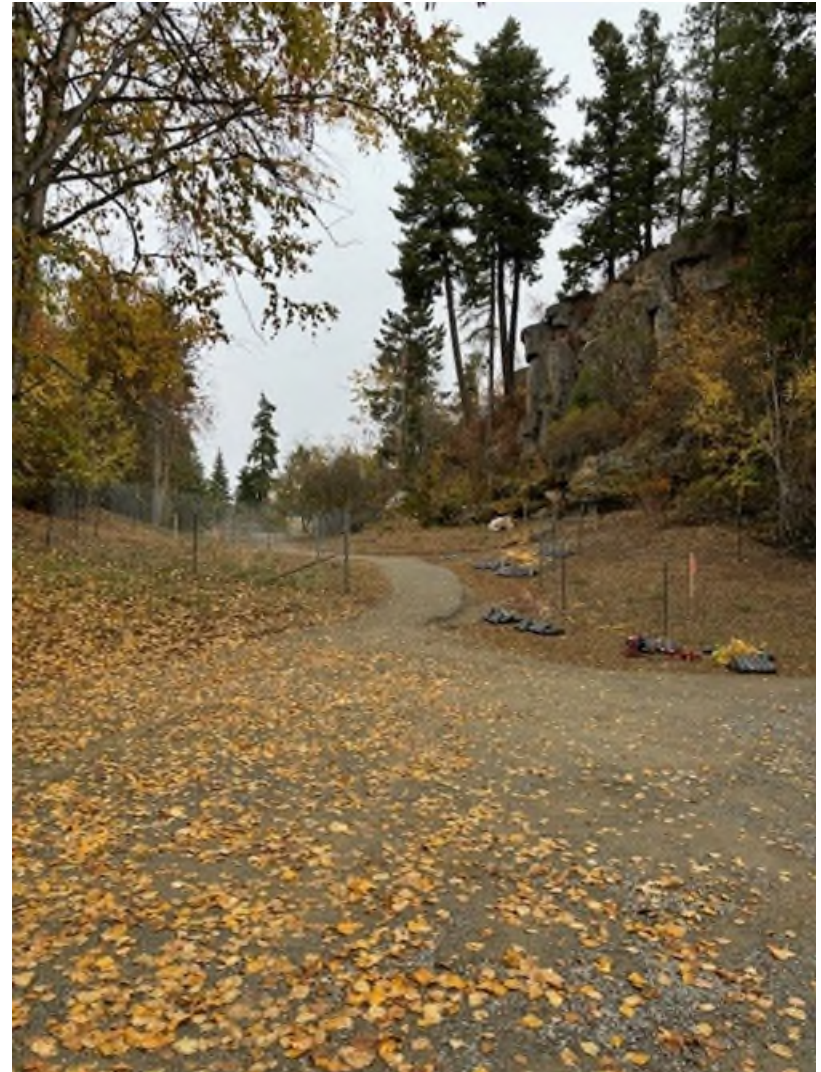
Revegetation

- Native plants – resilient to drought
- Browse protection
- Scheduled watering and maintenance

- 10 fence enclosures
- 40 individual browse protector cages

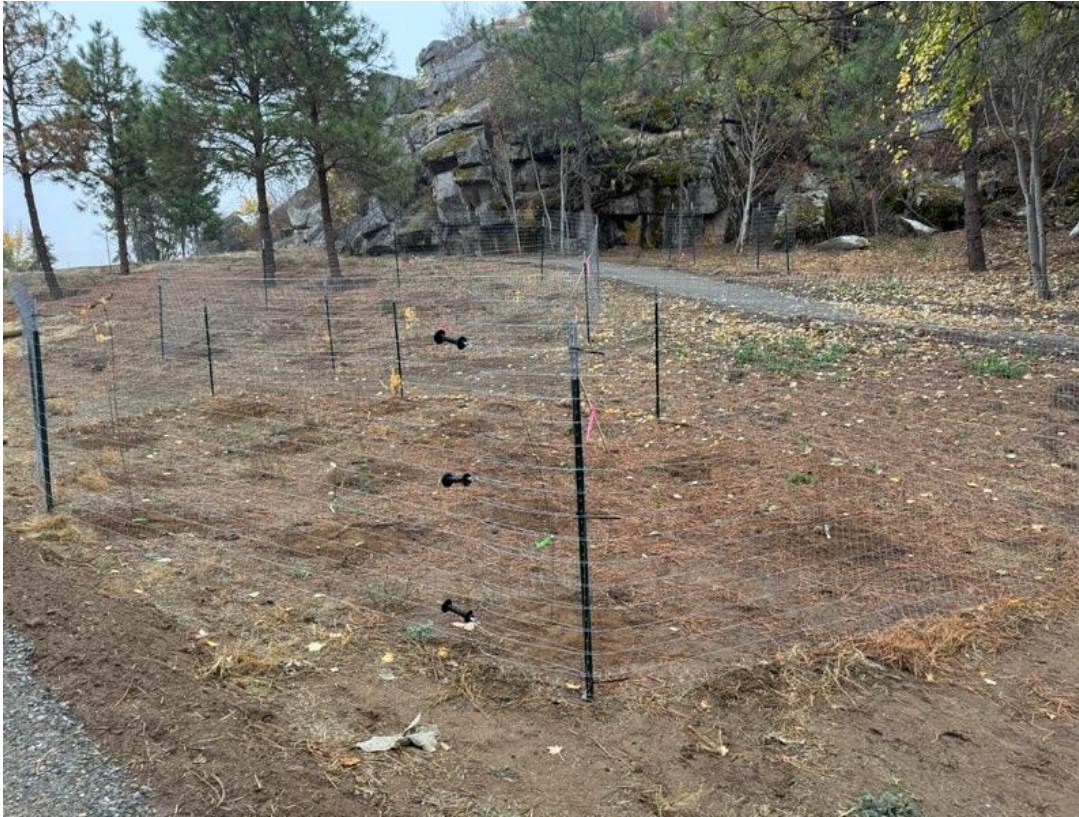
- 181 native trees and shrubs
- Seeded 1.08 acres with reclamation seed mix
- Installation of erosion control measures
